THE UNITED STATES
STRATEGIC BOMBING SURVEY

THE EFFECTS
OF
THE ATOMIC BOMB
ON
HIROSHIMA, JAPAN

Volume III

Physical Damage Division

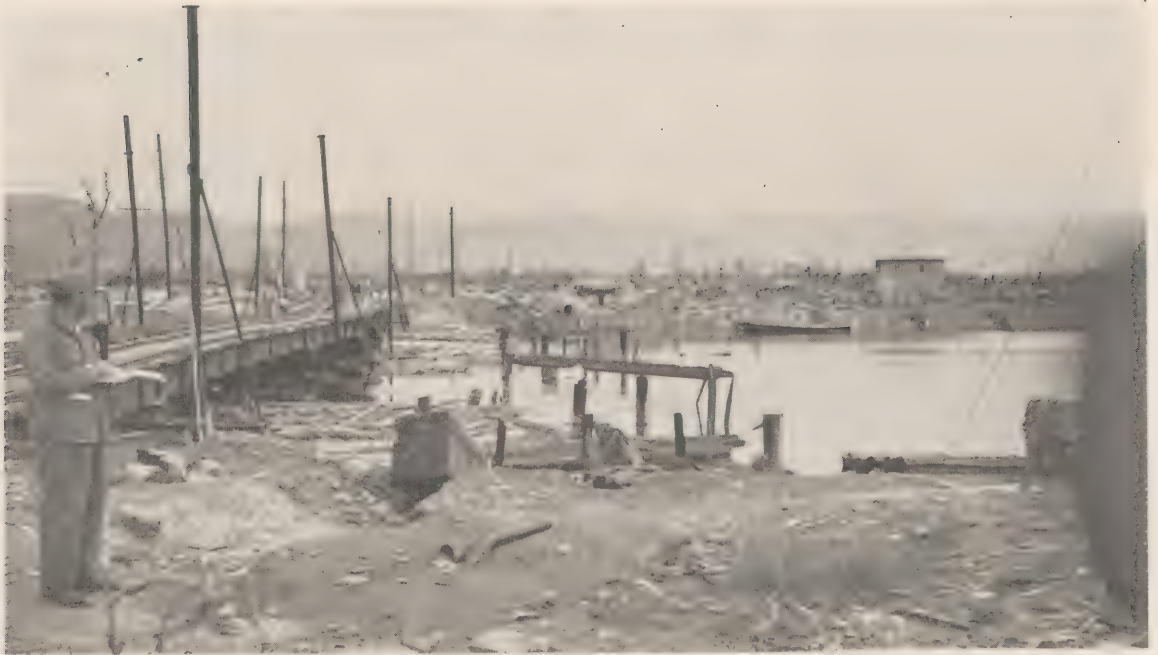
feet from AZ). The span adjacent to the west abutment was slightly damaged initially by blast and later the whole bridge was totally damaged by fire (Photos 31 and 32).

PHOTO 31-XII. Bridge 13-A. Looking east at totally damaged timber bridge by blast and fire over the Kyobashi-Gawa.

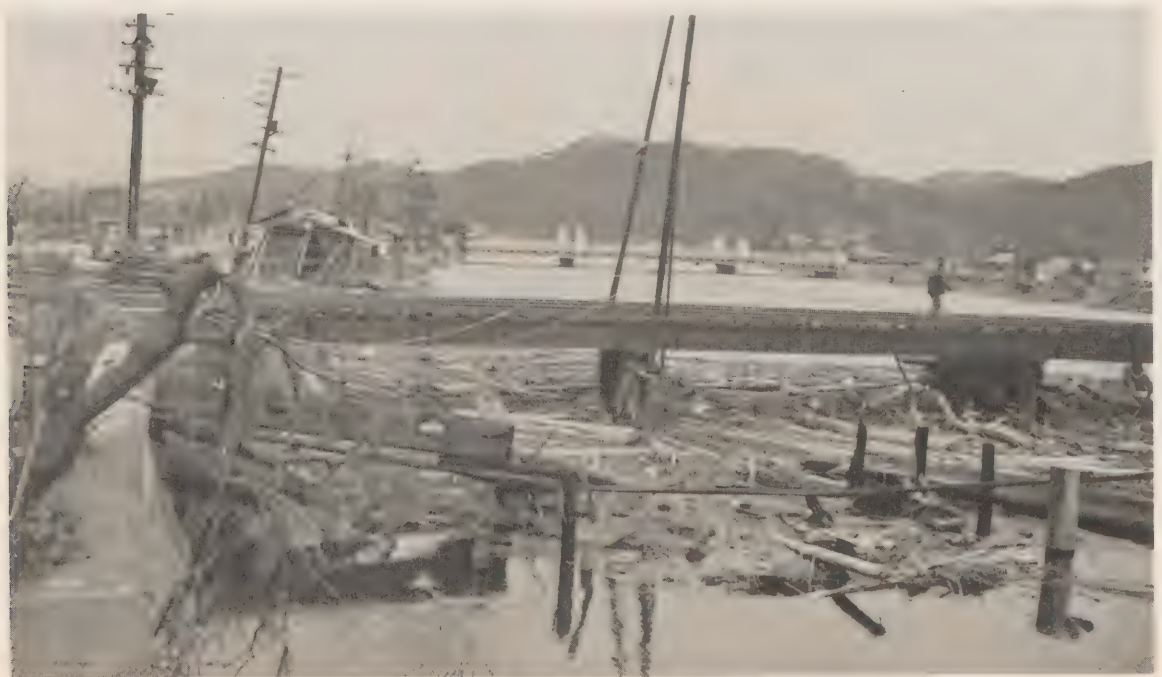
PHOTO 32-XII. Bridge 13-A. Totally damaged by blast and fire (4,670 feet to GZ, 5,080 feet to AZ.)

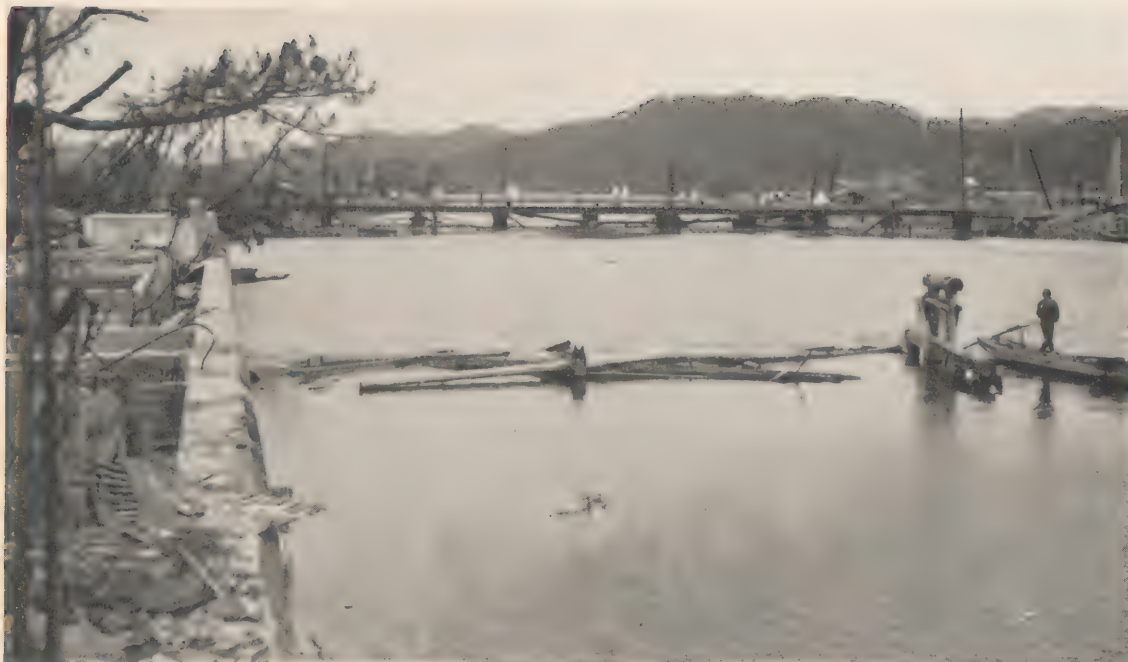
(5) *Bridge 14* (4,760 feet from GZ and 5,170 feet from AZ) was totally damaged by fire (Photo 33).

PHOTO 33-XII. Bridge 14. West abutment of bridge over the Kyobashi-Gawa, totally damaged by fire (4,760 feet to GZ, 5,170 feet to AZ).

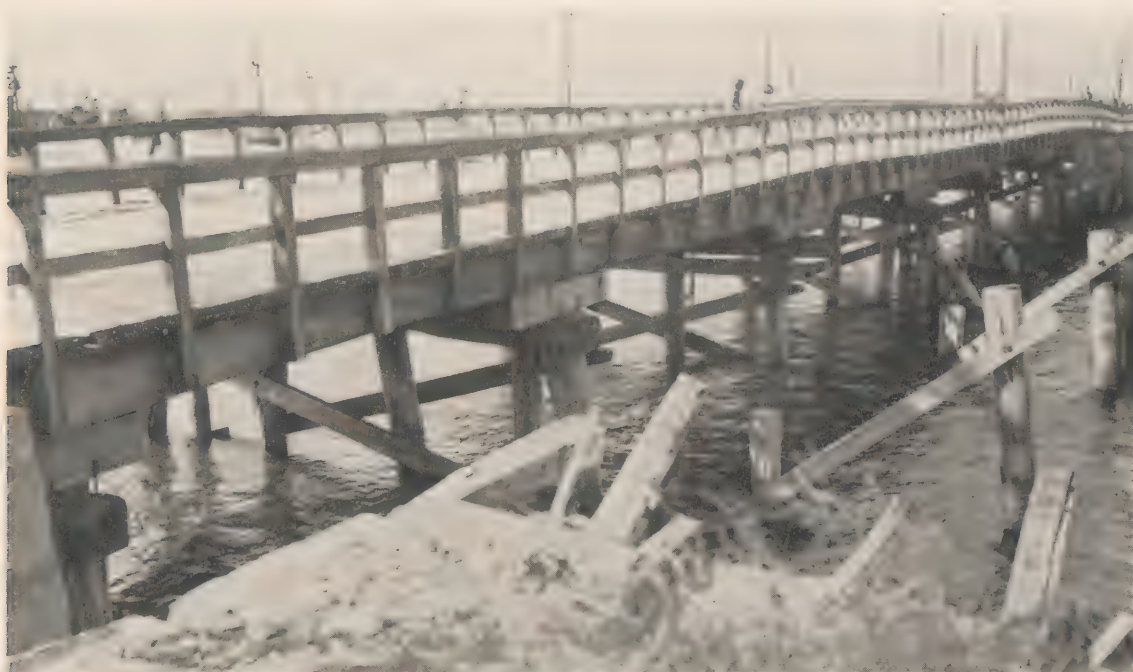
(6) *Bridge 15* (5,580 feet from GZ and 5,900 feet from AZ) suffered no damage (Photo 34).

PHOTO 34-XII. Bridge 15. Looking south at undamaged bridge over the Kyobashi-Gawa (5,580 feet to GZ, 5,900 feet to AZ).

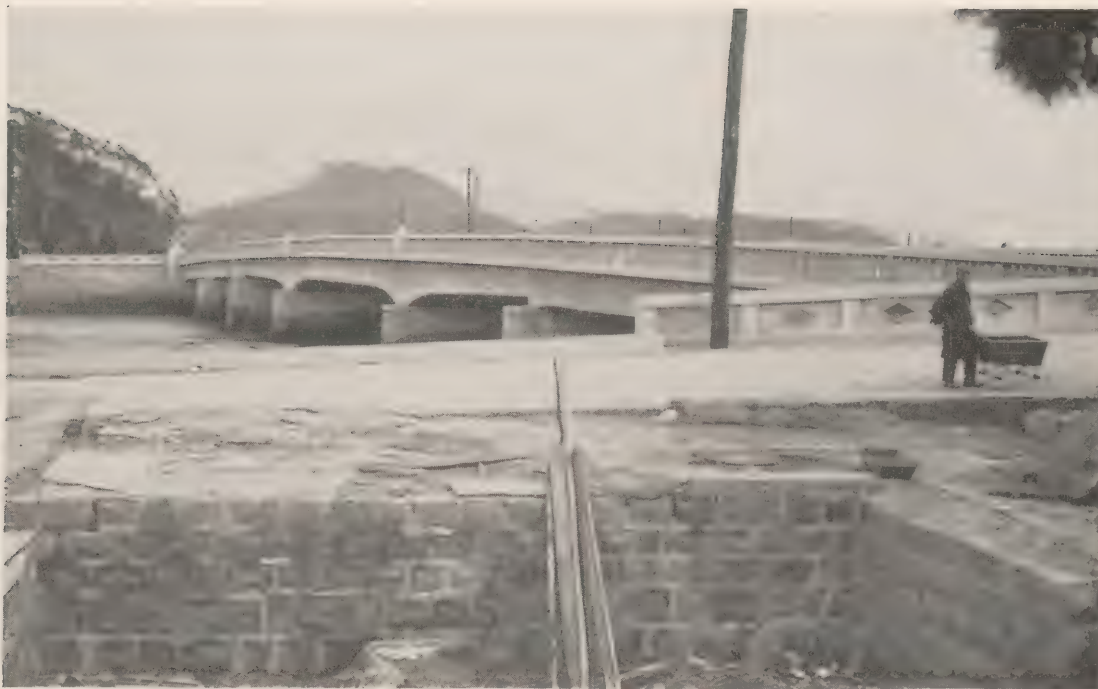
(7) *Bridge 16* (5,750 feet from GZ and 6,100 feet from AZ) suffered no damage (Photo 35).

PHOTO 35-XII. Bridge 16. North elevation of undamaged, reinforced-concrete, highway bridge over the Kyobashi-Gawa (5,750 feet to GZ, 6,100 feet to AZ).

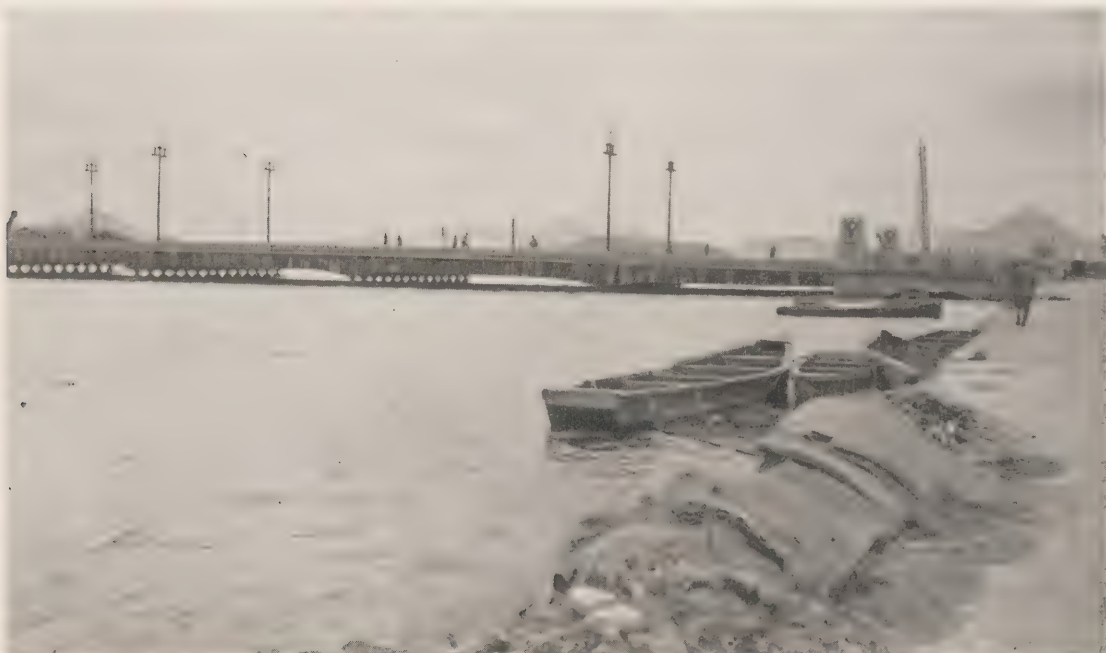
both concrete railings of the main spans being totally damaged. The railings of the approach spans were not damaged by blast (Photo 36). This was the most remote plate-girder bridge from GZ.

PHOTO 36-XII. Bridge 17. Looking south at street railway and highway plate-girder bridge over the Kyobashi-Gawa. Superficial blast damage to railings (7,600 feet to GZ, 8,870 feet to AZ).

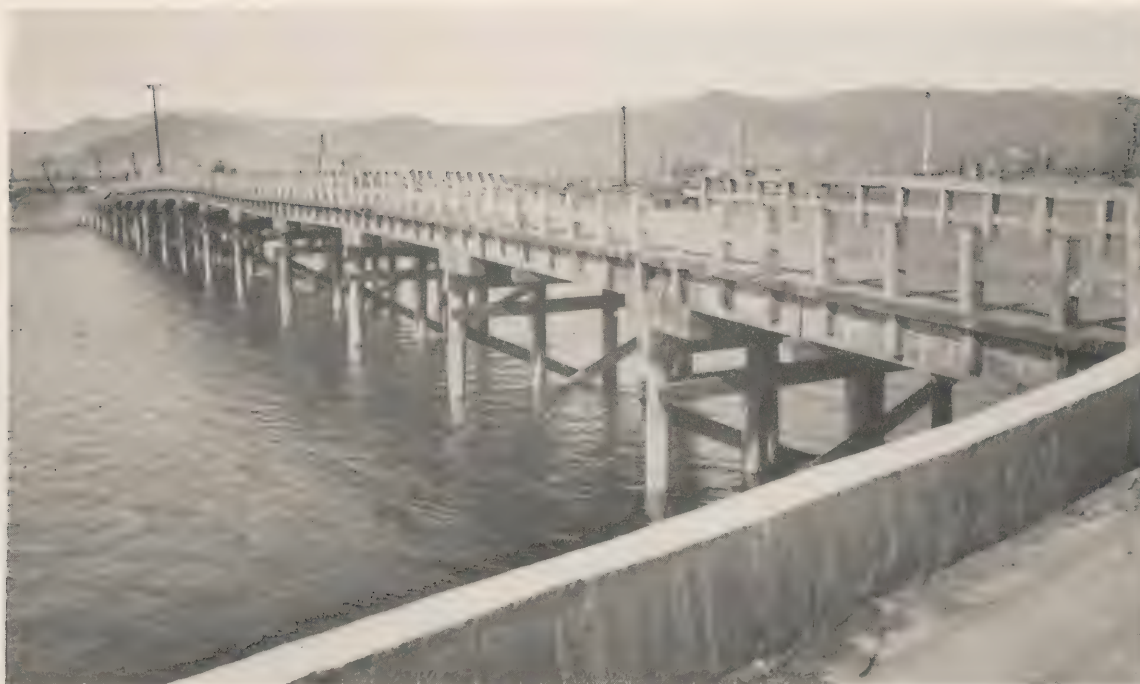
(7) *Bridge 18* (6,000 feet from GZ and 6,300 feet from AZ) suffered no damage (Photo 37).

PHOTO 37-XII. Bridge 18. Undamaged highway bridge over the Motoyasu-Gawa (6,000 feet to GZ, 6,300 feet to AZ).

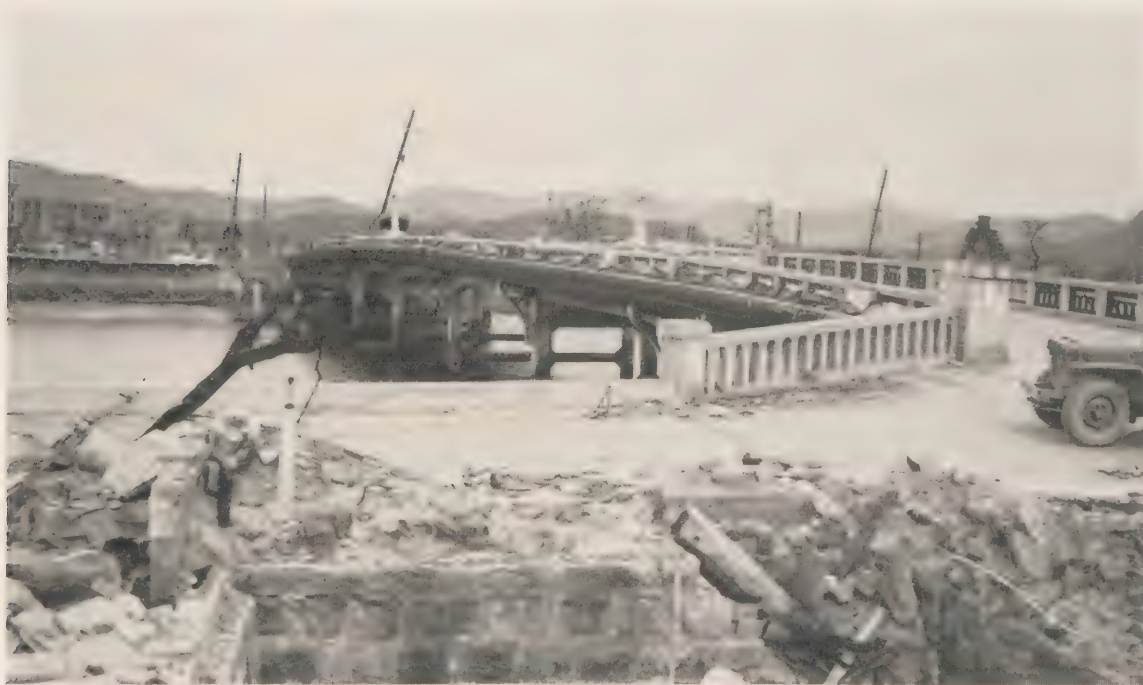
(8) *Bridge 19* (4,270 feet from GZ and 4,720 feet from AZ). This bridge suffered no structural damage but received superficial blast damage indicated by dislodged ornamental posts (Photos 38 and 38A).

PHOTO 38-XII. Bridge 19. North elevation of highway bridge over the Motoyasu-Gawa. Ornamental stone posts dislodged by blast (4,270 feet to GZ, 4,720 feet to AZ).

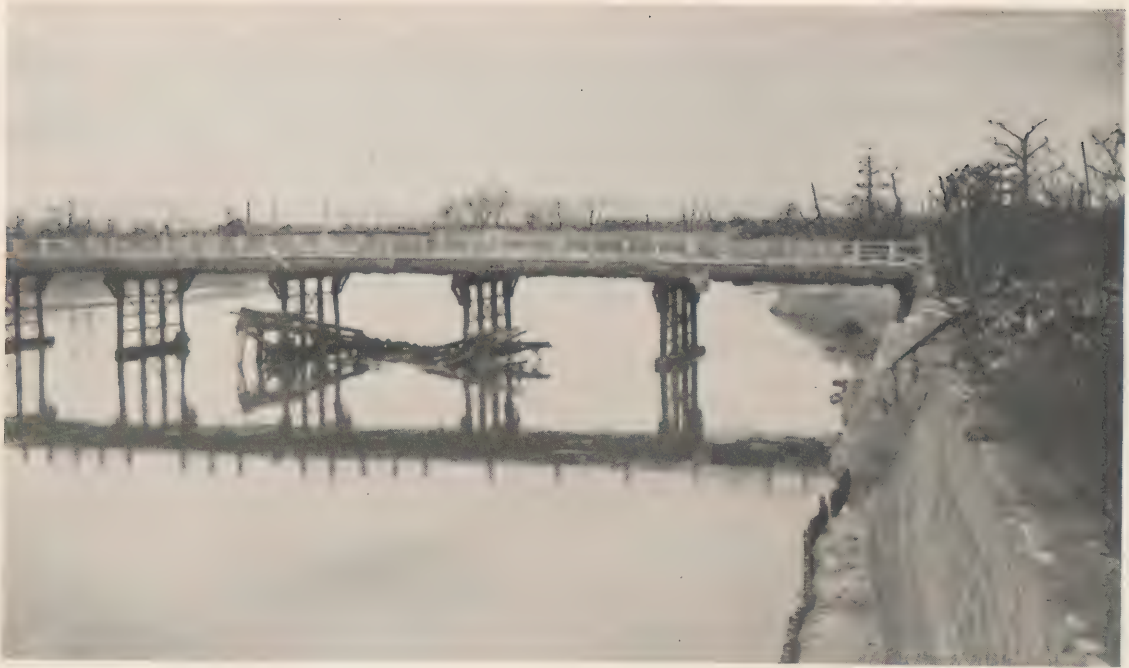
(9) *Bridge 20* (I-beam girder, 2,900 feet from GZ and 3,450 feet from AZ). This bridge suffered no structural damage by blast which, however, dislodged ornamental corner posts (photos 39, 40, and 41).

PHOTO 39-XII. Bridge 20. Looking south at slight blast damage to northwest area of bridge over the Motoyasu-Gawa.

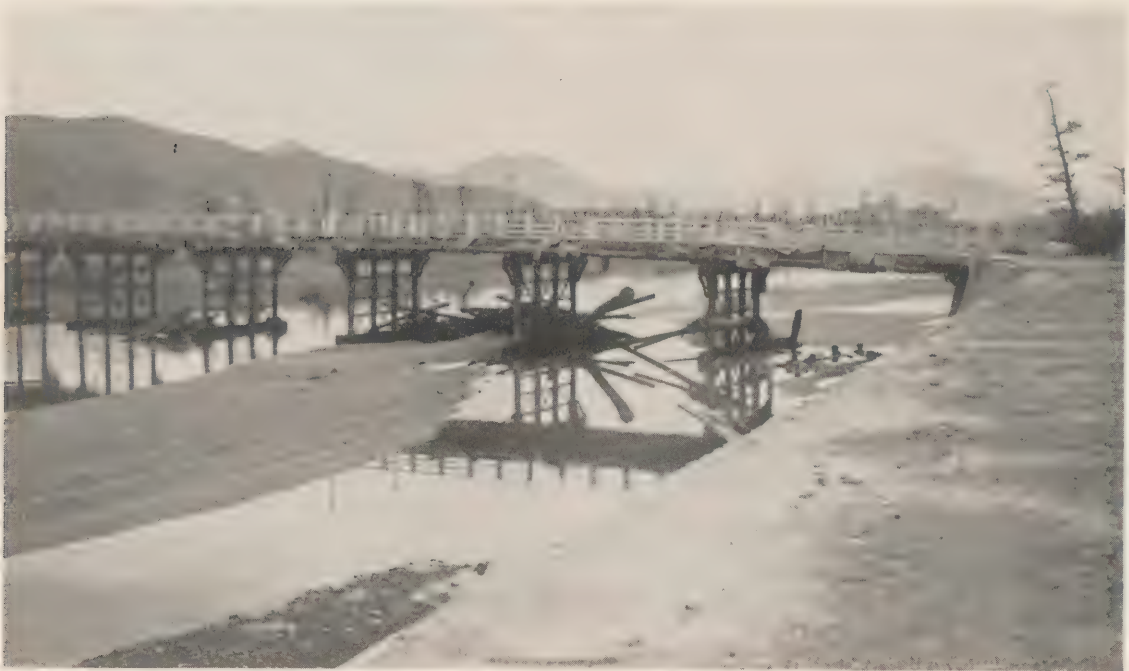
PHOTO 40-XII. Bridge 20. South elevation. Debris deposited against bents by flood (2,900 feet to GZ, 3,450 feet to AZ).

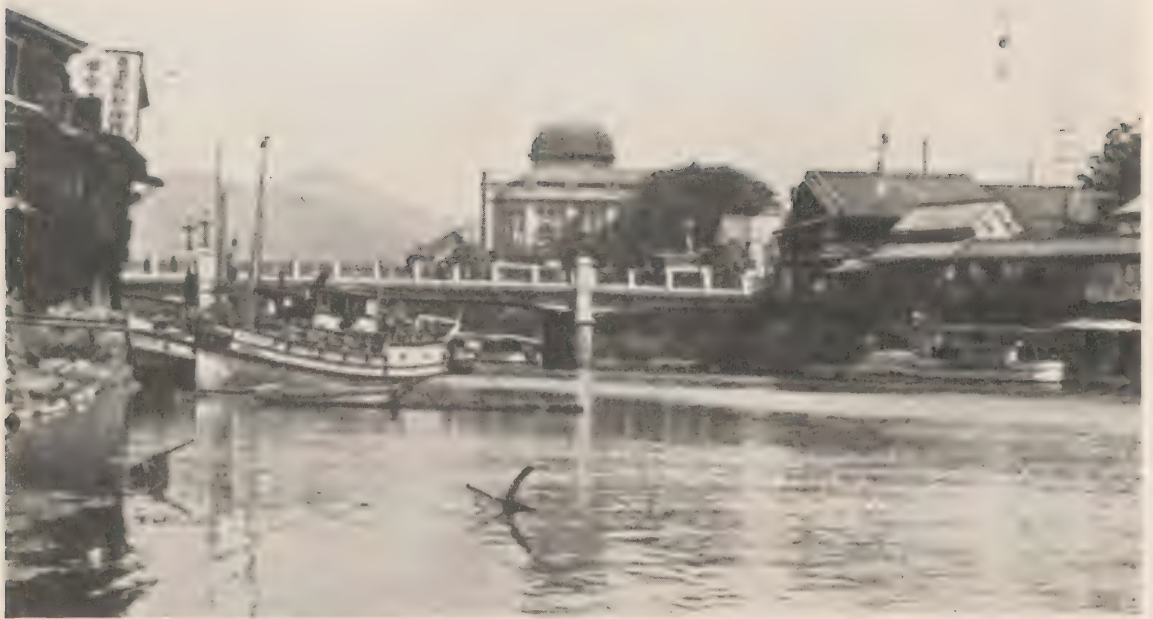
PHOTO 43-XII. Bridge 22. Pre-attack Japanese photo showing south elevation. Nearest bridge to GZ, 260 feet.

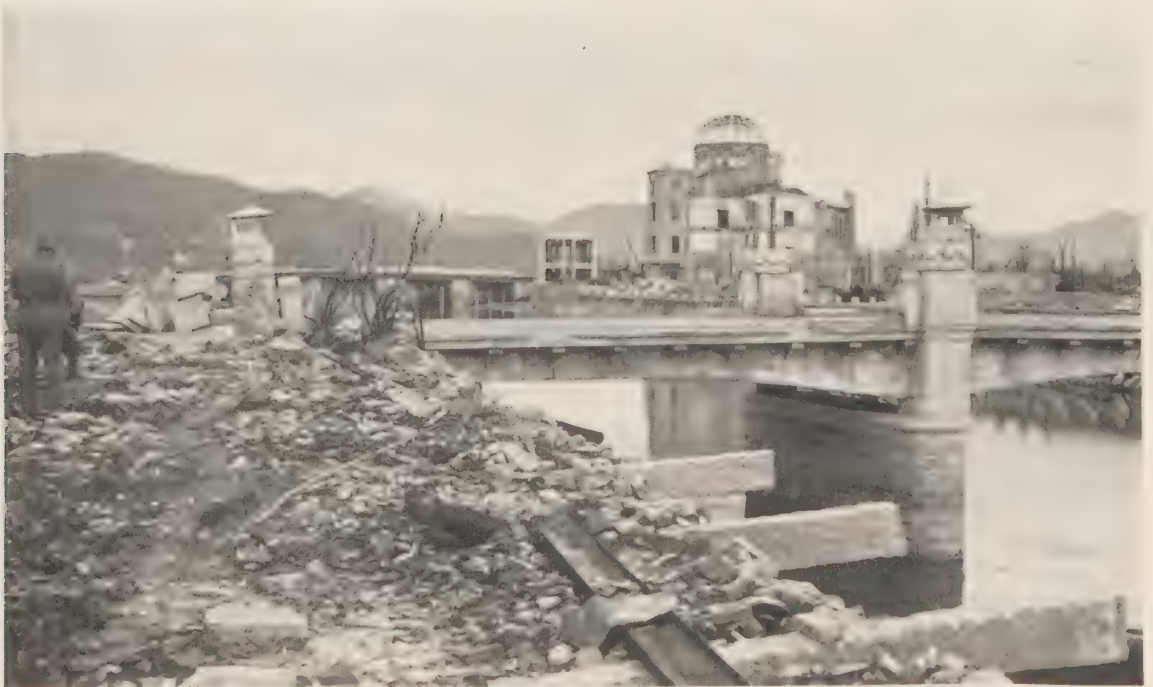
(10) *Bridge 22* (260 feet from GZ and 2,020 feet from AZ). Of plate-girder design, this was the nearest bridge to the zero points. It had four steel longitudinal girders arched at the center and haunched at their supports. The piers were concrete, faced with masonry. The roadway deck was of reinforced concrete with asphalt-wearing surface. The ornamental stone posts, two at east and west abutments and two at each river pier, were connected by concrete railings (Photo 43A). The bridge suffered no structural damage, although the north faces of the piers showed minor damage due to exposure to the blast. It did, however, receive superficial damage as the concrete railings on both sides were totally damaged and the ornamental posts were dislodged in a direction away from GZ (Photos 43-46 and Fig. 9). It appeared that the girders of the end span had lifted and had been slightly displaced at the abutments. The center span appeared to have been deflected and caused to rebound by the action of the blast which had shaken the entire bridge. Evidence also indicated that the joints of the water main spanning the river between the girders underneath the bridge were slightly damaged.

PHOTO 43A-XII. Bridge 22. Superficial blast damage to bridge over the Motoyasu-Gawa (260 feet to GZ, 2,020 feet to AZ).

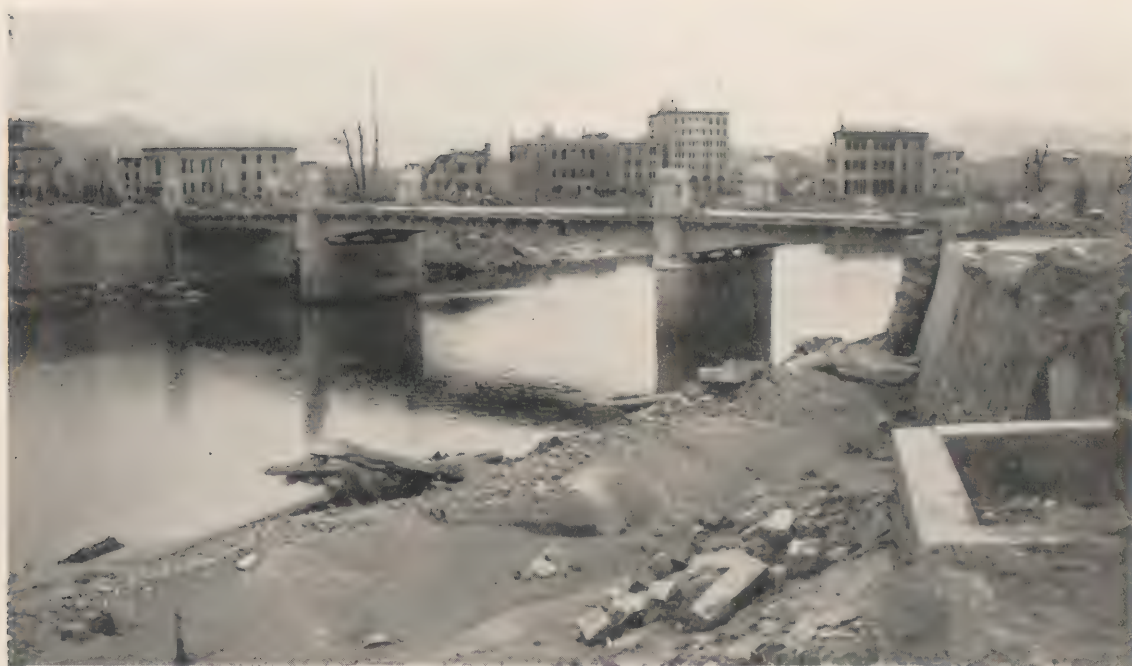
PHOTO 44-XII. Bridge 22. North elevation. No structural damage.

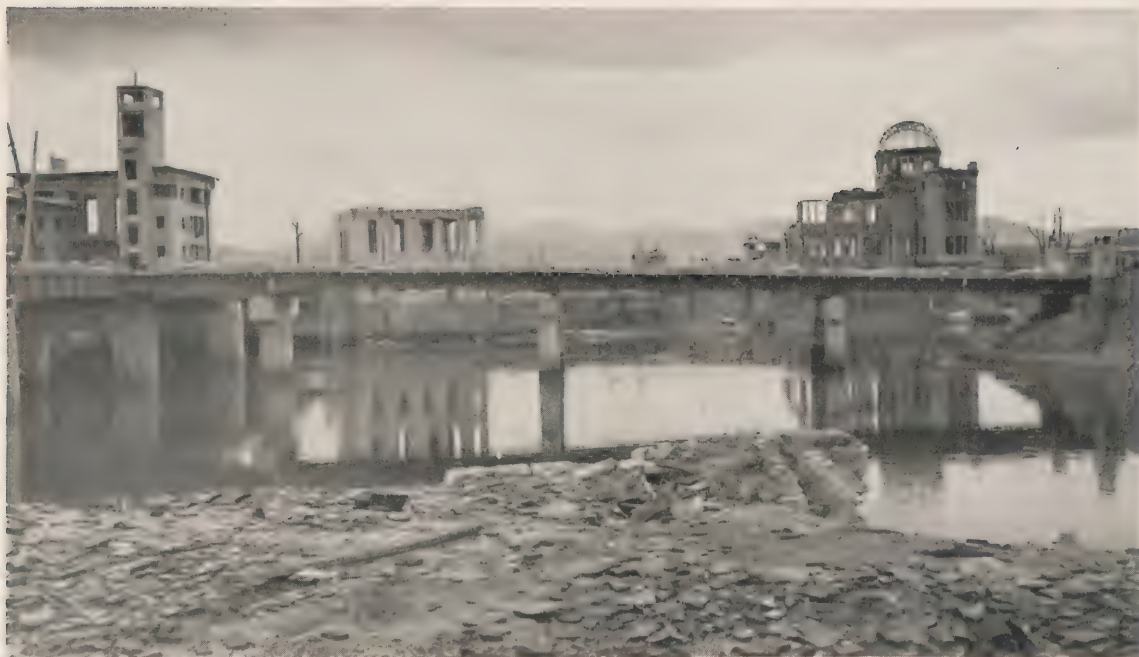
there was no indication of displacement of the abutment at the south end of the bridge. The longitudinal girders abutting the south face of Bridge 24 were of cantilever design and showed no indication of deformation (Photos 47 and 70).

PHOTO 47-XII. Bridge 23. Looking east at west elevation. Note cantilever span adjacent to Bridge 24, over the Ota-Gawa.

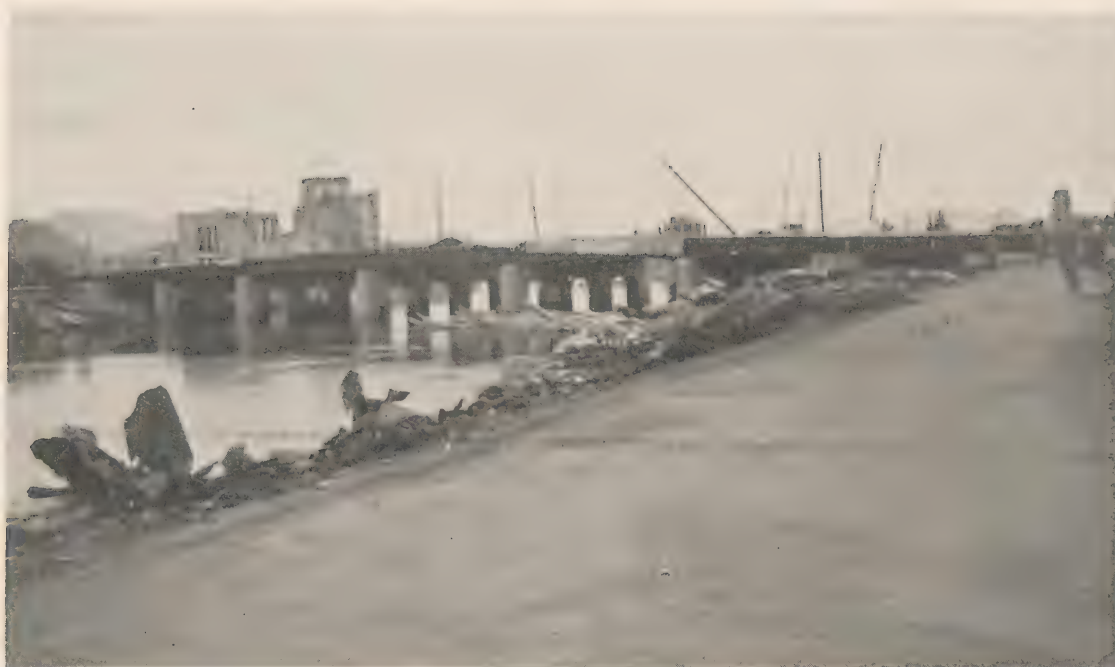
(12) *Bridge 24* (1,000 feet from GZ and 2,230 feet from AZ) was located at the intersection of the Ota and Motoyasu Rivers (Photo 70). This bridge of plate-girder design received physical damage of a spectacular and interesting nature but it continued to carry unrestricted highway, pedestrian, and street railway traffic. The longitudinal steel girders suffered no great structural damage although a slight lateral deformation indicated that they had been highly stressed. It was also apparent that the bridge had first been depressed by the blast, and then the girders rebounded upward due to the elastic quality of the steel. Apparently the reflection of the blast wave from the river and the rebounding action raised the roadway and sidewalk slabs from their supporting girders and also moved them laterally at the west end spans of the bridge (Photos 58 and 69) in a direction away from the blast. Although the girders were subjected to large and unusual stresses, the elastic limit of the material was not greatly exceeded. The longitudinal girders, however, did suffer slight deflection, especially those girders under the concrete walk adjacent to the east abutment where they were deflected approximately 2 to 3 inches downward at the center of the span (Photos 62 and 63), and there was a slight lateral deflection (Photos 53, 66, and 67). The girders at the west abutment showed an indication of deformation (Photo 64). The longitudinal girders of the fourth and fifth spans from the east abutment underneath the north walk were slightly deformed laterally and vertically, indicating that stresses were built up in the web-plate and bottom flanges at the piers. The concrete railings were totally damaged. The cast-iron posts encased in the concrete railings were sheared off at curb level, apparently as a result of severe shock effects produced by the blast. The railings were anchored securely to the concrete deck and curbs. This anchorage was provided by the cast-iron posts which were bolted to the outside girder and spaced 6 feet on centers (Photo 61). Other interesting damage features occurred at Bridge 24, such as damaged walks, roadway deck, and granite curbs. These damage features resulted from the shifting of the roadway deck laterally and vertically due to bomb

PHOTO 50-XII. Bridge 24. North elevation of bridge over Ota-Gawa. Concrete walk and railing damaged by blast.

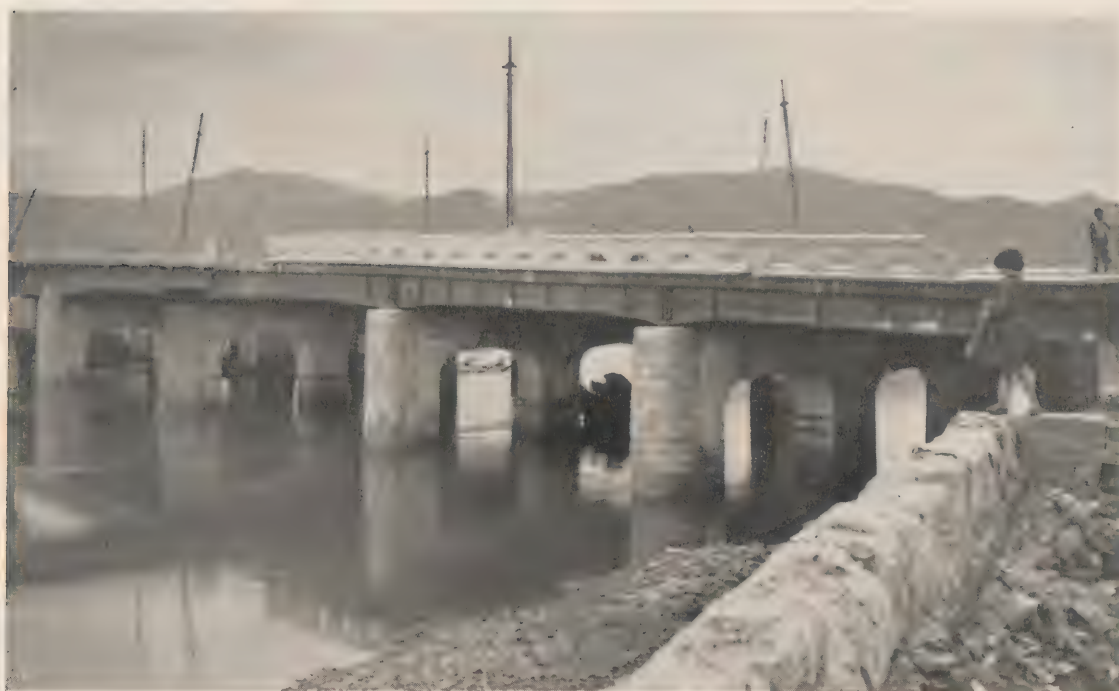
PHOTO 51-XII. Bridge 24. Southeast part of bridge over Ota-Gawa. Railing damaged by blast (1,000 feet to GZ, 2,230 feet to AZ).

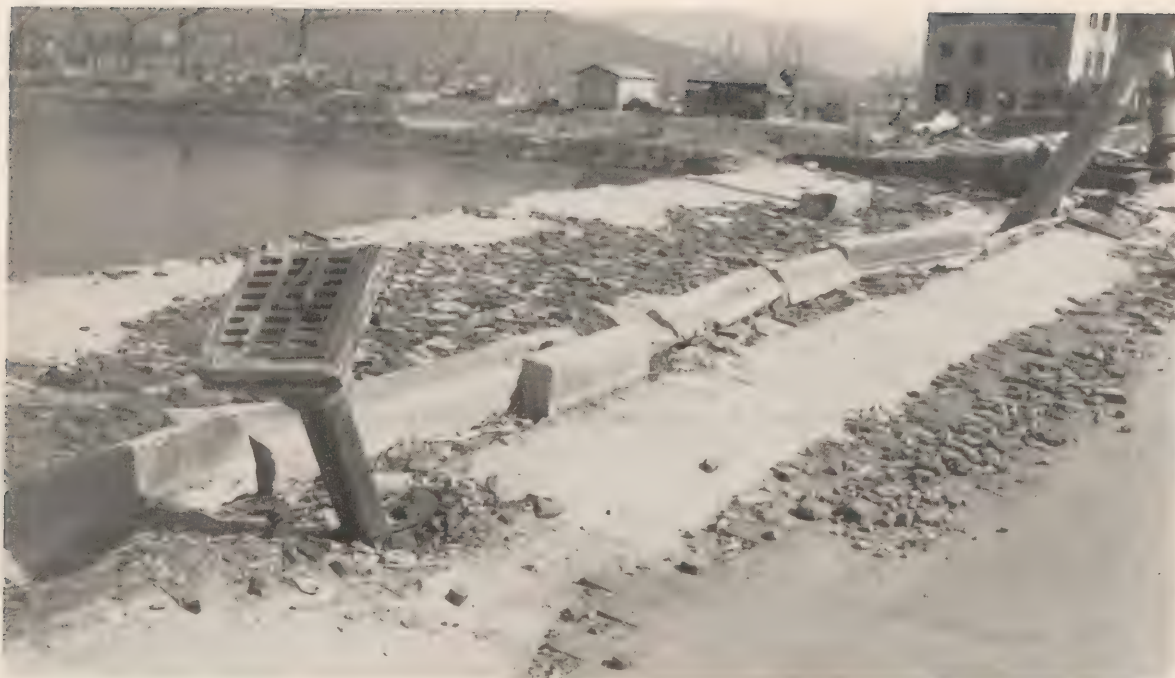
effects. The concrete walk along the north side was pushed approximately 3 feet above its supporting members over the center span (Photo 65). Along the north gutter, the scupper drains were left approximately 2 feet above the roadway because the deck was raised so high off the steel and shifted so far that the scupper pipes hit on girders in falling (Photos 54, 55, 57). Approximately at the bridge center the roadway deck was shifted laterally 15 inches north and raised approximately 14 inches above its original position (Photos 54, 55, 57, and 65). When raised and shifted laterally, the edge of the slab landed on the sidewalk-supporting steel which was at a higher elevation (Figs. 11 and 12). Also at approximately bridge center (opposite Bridge 23) the rails of the south street railway track were raised about 8 inches above their original position. This movement was caused by reflected blast which, however, did not affect Bridge 23 because of the nonrigid connection of the cantilever span abutting the south face of Bridge 24 (Photo 60). The southwest area of Bridge 24 was also affected by blast which raised the concrete walk approximately 20 inches above its original elevation and displaced the granite curb laterally 9½ inches north from its original position. The roadway concrete deck, concrete walk, and granite curb at the northwest corner of the bridge (Photo 59) were also damaged by blast. The shifting of the bridge deck caused a slight lateral deflection in the street railway rails at the east end of the bridge (Photo 68) and also moved the rails laterally 15 inches to the north from their original position at the west end of the bridge (Photo 69). The ornamental stone caps at the corners of Bridge 24, with the exception of the southeast posts, were dislodged by the bomb effects (Fig. 12 and Photo 70). It was learned through interrogation that at the time of the blast approximately 300 Japanese soldiers and many civilians were crossing the bridge and all were hurled into the river.

PHOTO 54-XII. Bridge 24. Portion of north granite curb and walk. Drain scupper west of Bridge 23, elevated 20 inches above road grade by blast effects.

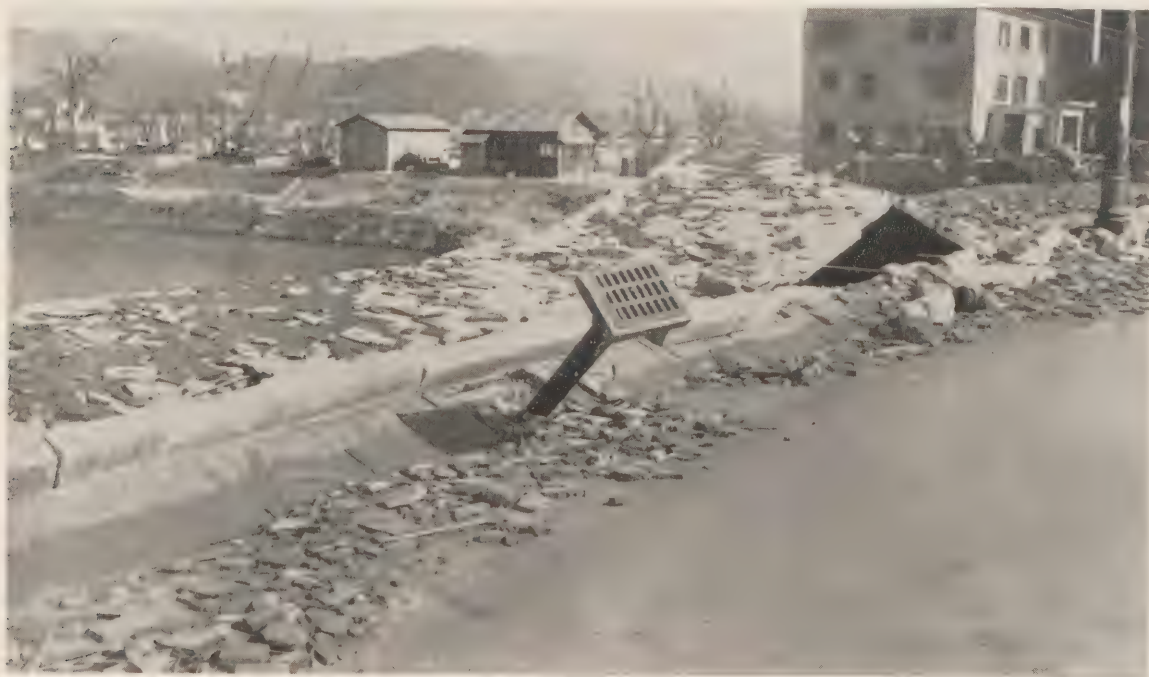
PHOTO 55-XII. Bridge 24. Portion of north granite curb and walk. Drain scupper east of Bridge 23, elevated 24 inches above road grade by blast effects (1,000 feet to GZ, 2,230 feet to AZ).

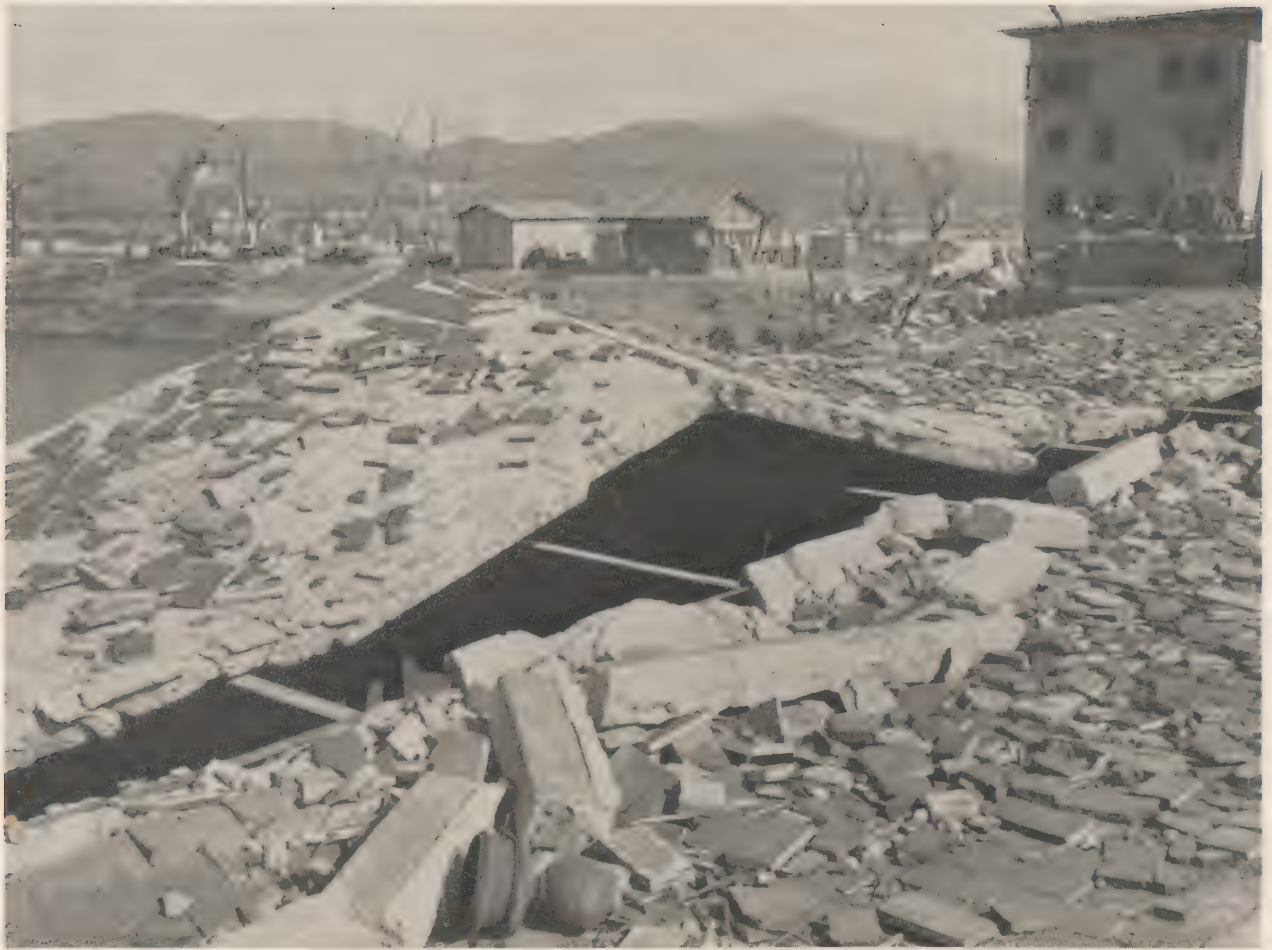
PHOTO 56-XII. Bridge 21. North concrete walk pushed by blast effects 38 inches above cross-steel members supporting the north walk (1,000 feet to GZ, 2,230 feet to AZ).

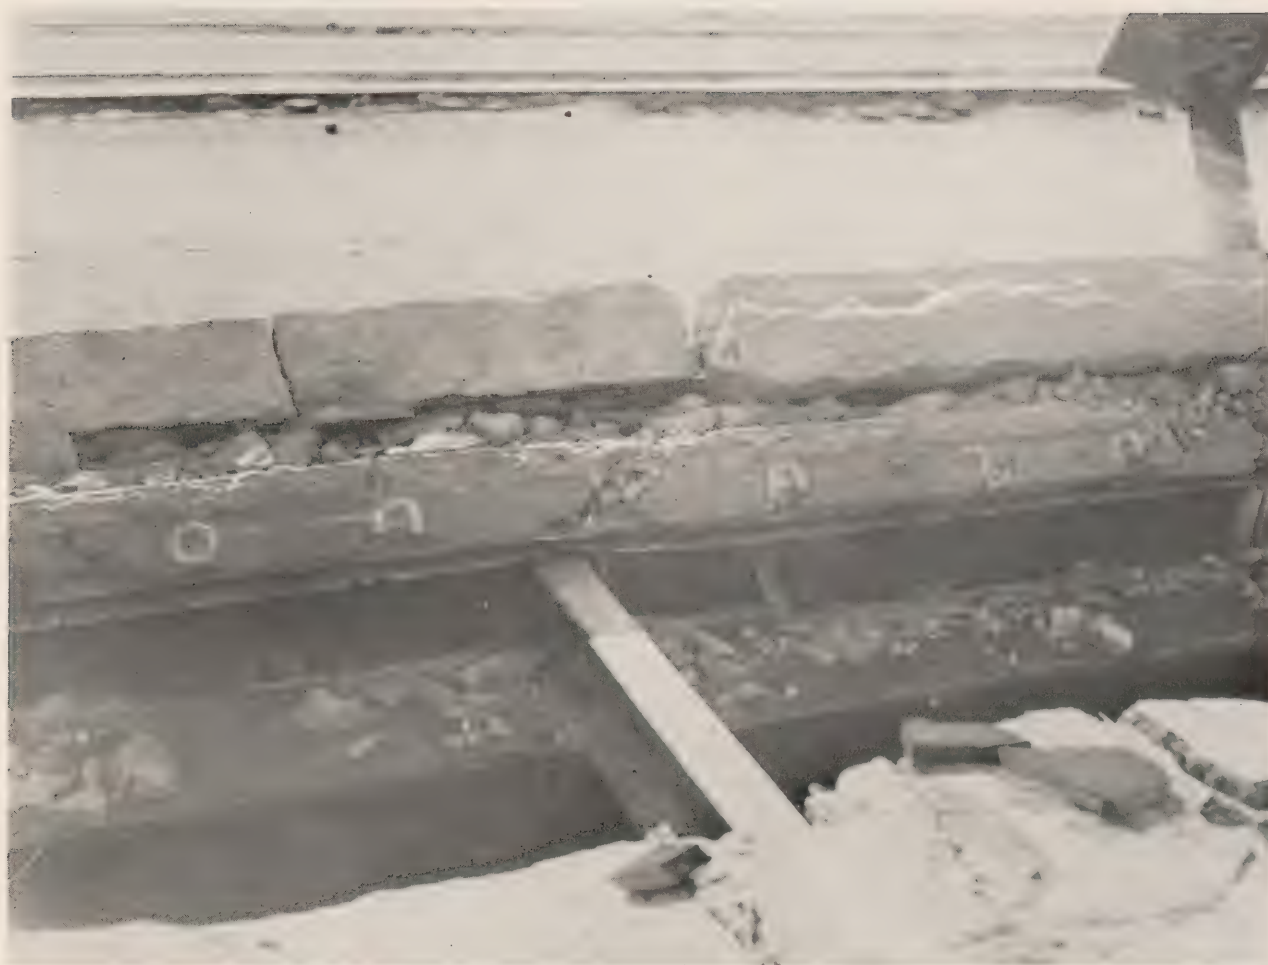
PHOTO 57-XII. Bridge 24. Blast effects moved roadway slab laterally 15 inches north and raised it 14 inches above original position. Note pushed-up scupper (1,000 feet to GZ, 2,230 feet to AZ).

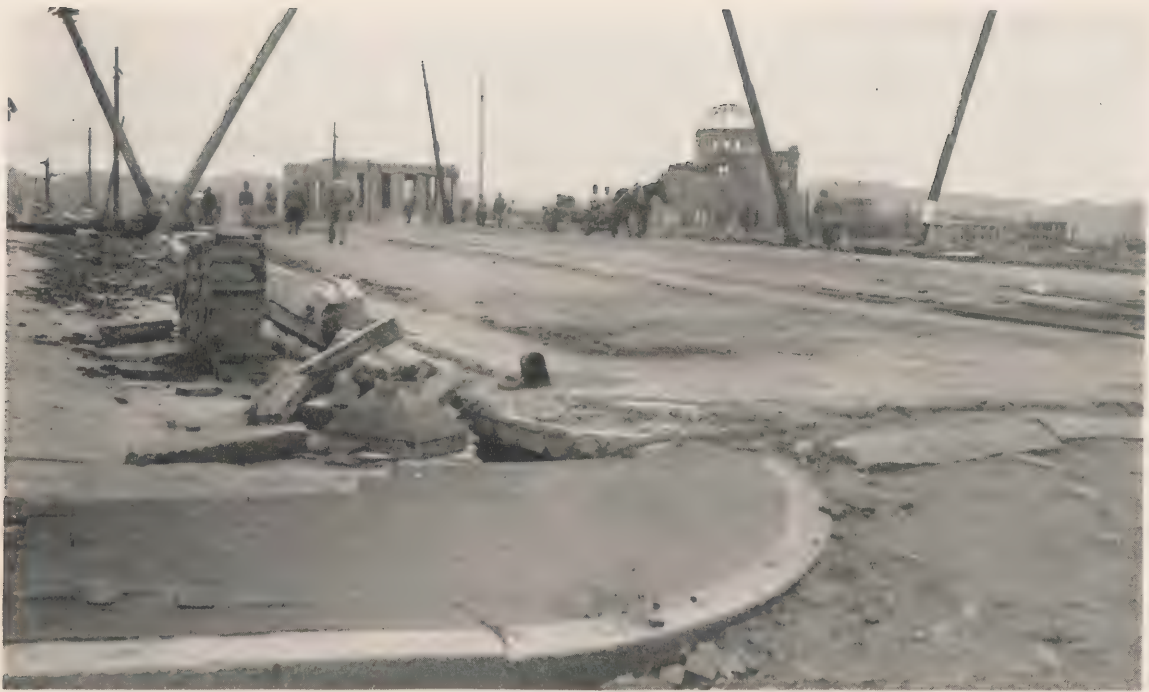
PHOTO 58-XII. Bridge 24. Northwest corner of bridge showing blast damage to concrete walk, granite curb and roadway concrete deck.

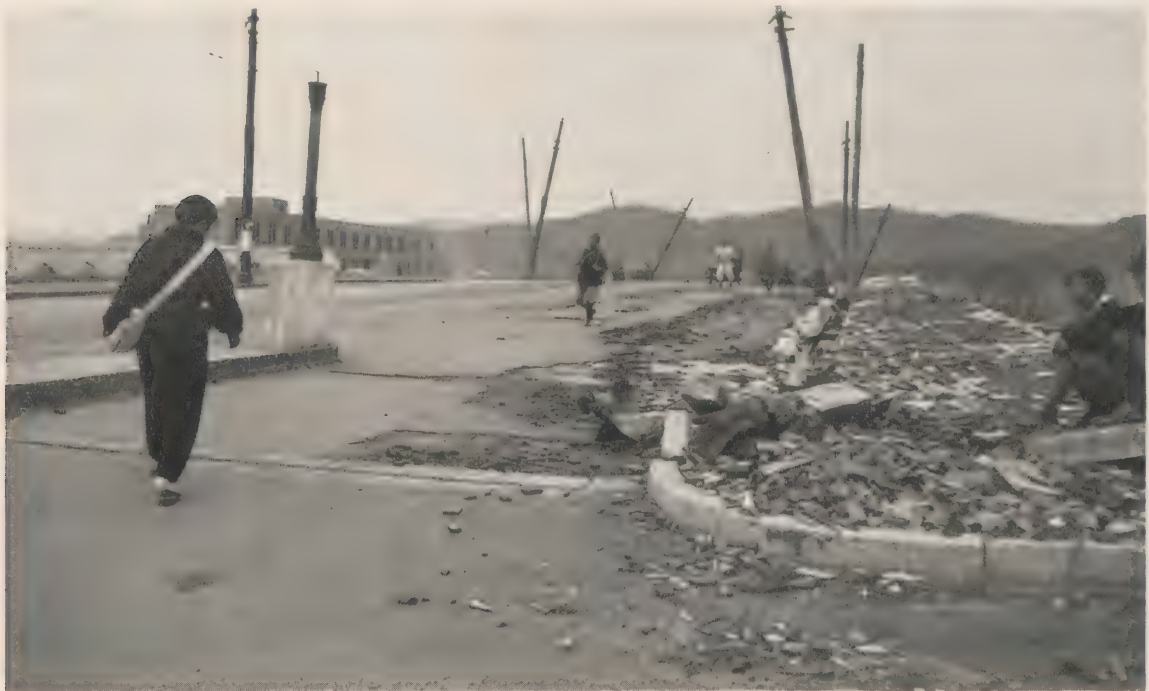
PHOTO 59-XII. Bridge 24. Northeast corner of bridge showing blast damage to concrete walk and granite curb (1,000 feet to GZ, 2,230 feet to AZ).

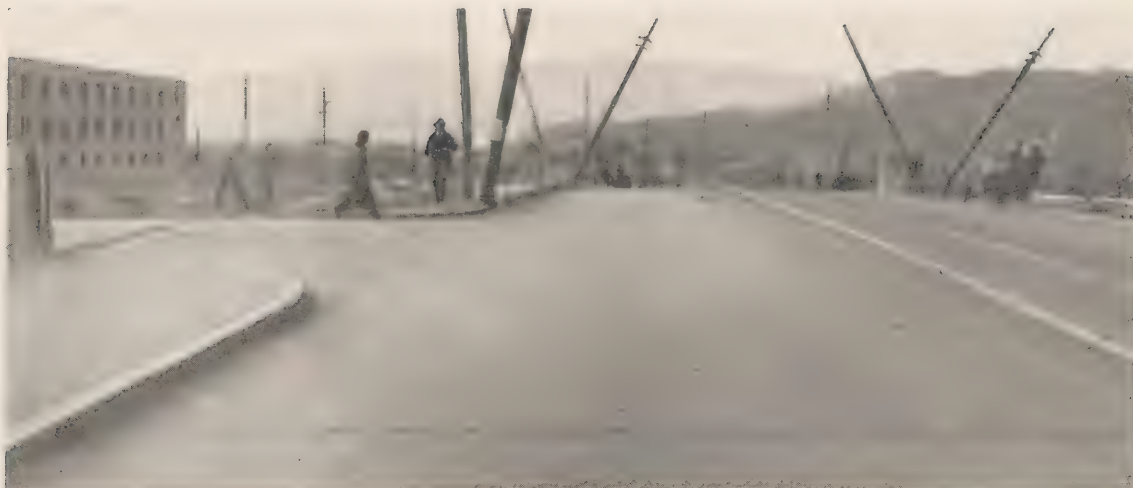
PHOTO 60-XII. Bridge 24. Intersection of Bridges 23 and 24. Rails of south railway tracks pushed up 8 inches above original road grade by blast.

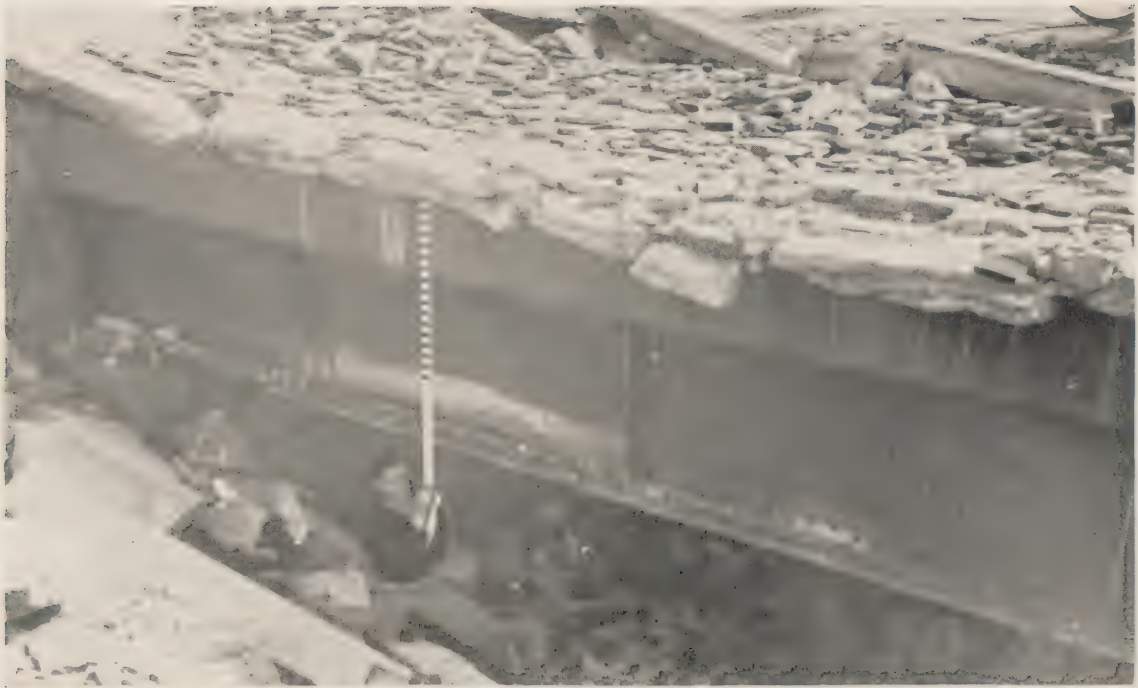
PHOTO 62-XII. Bridge 24. Northeast corner of steel-plate girder. No structural damage by blast.

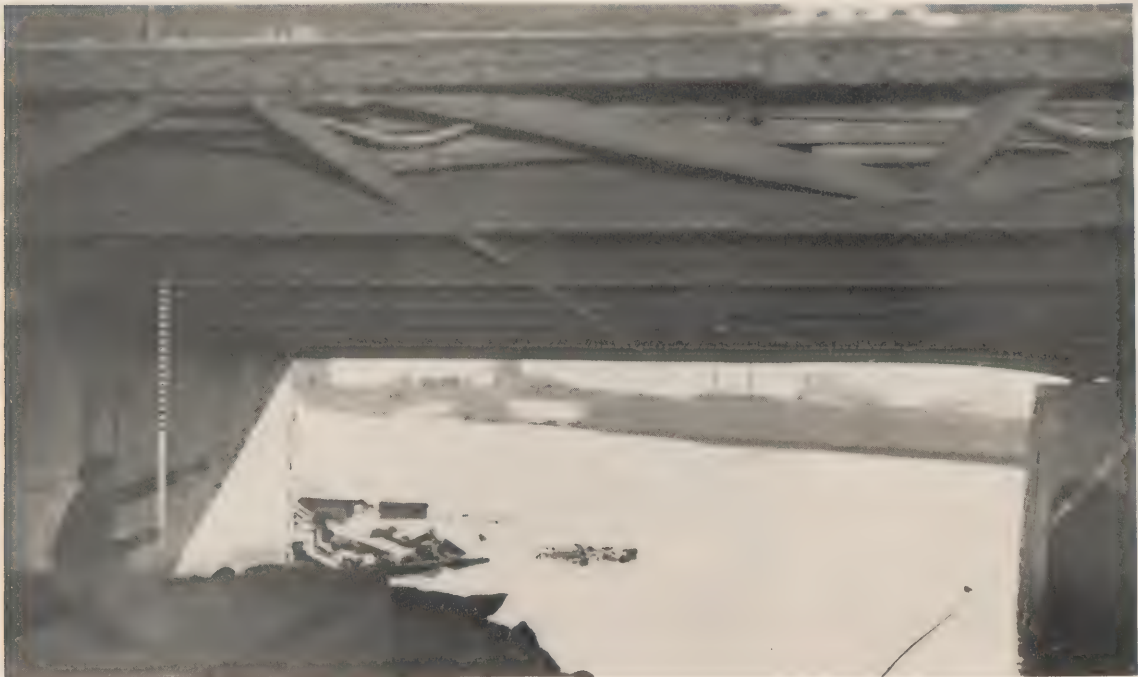
PHOTO 63-XII. Bridge 24. Underside of steel-plate girders and cross-members of west abutment. No structural damage (1,000 feet to GZ, 2,230 feet to AZ).
